**Flood Control Project Maintenance  
Levee Inspections**

**Fall 2018 Levee Maintenance Deficiency Summary Report**

**LMA District Cover Sheet**  
**Fall 2018 Levee Inspection Results**

**Sutter Maintenance Yard Maintenance Area 0005**

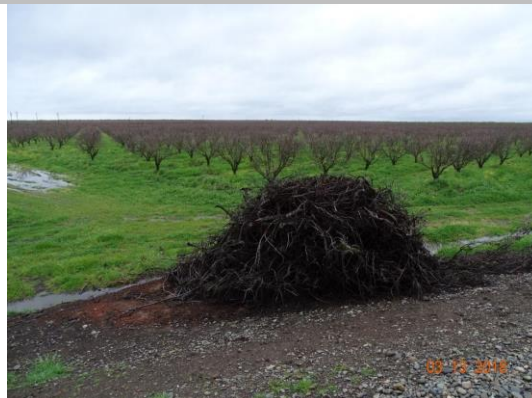
Photo 1 of 1 : FA\_2018\_MA0005\_197\_65\_20180905\_00034.jpg

View of the prunings along the landside toe.

LM Start	6.90	Rating **	M	Issue No.	65
LM End	6.90	Issue Type +	En	Location *	LS
Category	Earthen Levee			GPS Latitude/Longitude	
				Start	End
Item	Encroachments			39.594827 °	39.594827 °
				-121.797080 °	-121.797080 °
DWR ID	DWR_MA0005_02_s_2018_65				
Comment Code					
PR : Prunings					
Inspector Comment					
Remove the prunings from the landside toe.

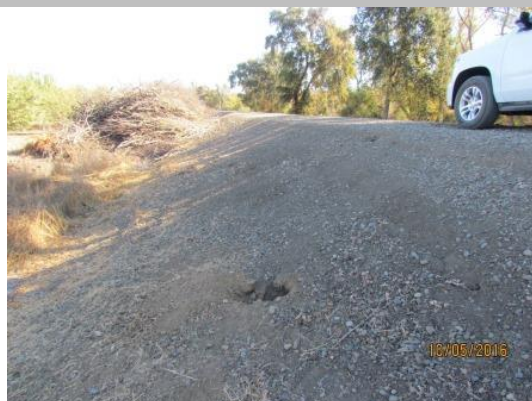
Photo 1 of 2 : FA\_2018\_MA0005\_197\_53\_20180905\_00025.jpg

LM Start	7.74	Rating **	U	Issue No.	53
LM End	7.74	Issue Type +	Ma	Location *	LS
Category	Earthen Levee			GPS Latitude/Longitude	
				Start	End
Item	Animal Control			39.605088 °	39.605088 °
				-121.788569 °	-121.788569 °
DWR ID	DWR_MA0005_02_f_2016_53				
Comment Code					
A1 : Exterminate rodents and backfill and compact or grout burrows.					
Inspector Comment

View of the rodent holes along the landside slope.

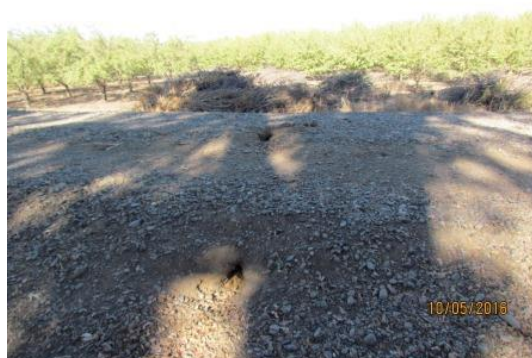
Photo 2 of 2 : FA\_2018\_MA0005\_197\_53\_20180905\_00026.jpg

View of the rodent holes along the crown and waterside slope.

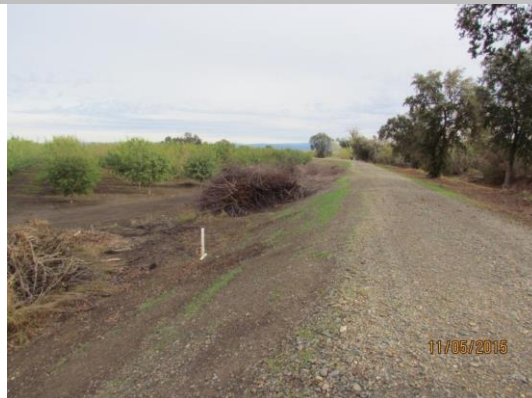
Photo 1 of 1 : FA\_2018\_MA0005\_197\_35\_20180905\_00012.jpg

LM Start	7.75	Rating **	M	Issue No.	35
LM End	7.75	Issue Type +	En	Location *	LS
Category	Earthen Levee			GPS Latitude/Longitude	
				Start	End
Item	Encroachments			39.605205 °	39.605205 °
				-121.788453 °	-121.788453 °
DWR ID	DWR_MA0005_02_s_2015_35				
Comment Code					
PR : Prunings					
Inspector Comment					
Remove the prunings from the landside slope.

View of the prunings along the landside slope.

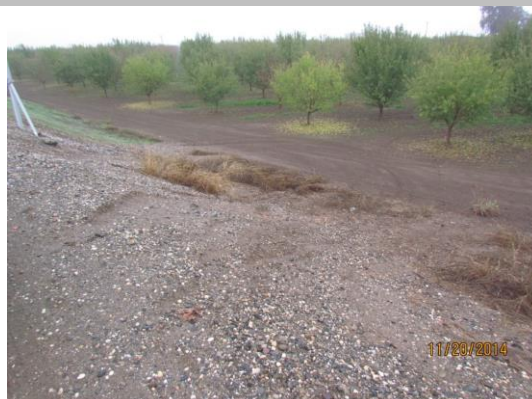
Photo 2 of 2 : FA\_2018\_MA0005\_197\_13\_20180905\_00006.jpg

LM Start	7.98	Rating **	M	Issue No.	13
LM End	7.98	Issue Type +	Ma	Location *	LS
Category	Earthen Levee			GPS Latitude/Longitude	
				Start	End
Item	Slope Stability			39.607710 °	39.607710 °
				-121.785868 °	-121.785868 °
DWR ID	DWR_MA0005_02_s_2012_13				
Comment Code					
S3 : Repair the levee slope damaged by vehicle traffic and prevent access where possible.					
Inspector Comment

View of the vehicle erosion along the landside slope.

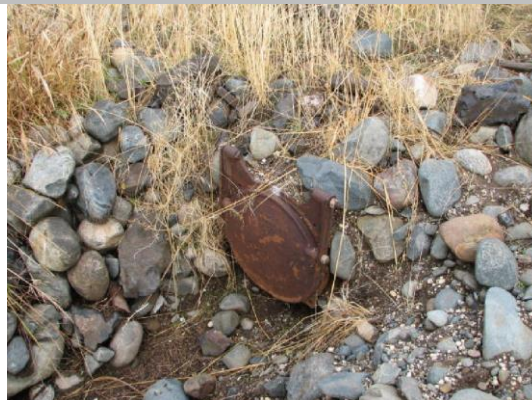
Photo 1 of 2 : UCIP\_FA\_2018\_52052\_68129.jpg

Comment Code					
Inspector Comment					
FS_ID:52052 DS_ID:1656 EP_NO: N/A Repair Type: Non-Urgent Crossing Status: Found UCIP Comments: 5/18/2017 LS inlet is almost completely full of soil. Pipe has been selected to be internally cleaned and inspected as part of the DMP project. (DWR Sutter Yard- A Freitag)11/14/2016 LS inlet almost completely full of soil. (DWR Sutter Yard- A Freitag)5/23/2016 LS end is almost completel full of soil.7/28/2015 Pipe is still over 3/4 full of soil. 11/24/2014 Same as last inspection.6/04/2014 Same as last inspection.11/12/2013 Same as last inspection.6/6/2013 Same as last inspection.10/31/2012 Pipe 3/4 full with soil on LS. FIELD_STRUCT_DESC: 24-inch (not 18-inch as shown in as-built drawing) corrugated metal drainage pipe through the levee, 6.7 feet below the crown. Concrete headwall at the landside (LS) toe. Flap gate on the waterside (WS). [Additional Reference(s): DWR Levee Log, 1990. USACE Sacramento O&M Manual 516, April 1960, (Station 379+98). USACE As-Built Drawing No. 50-4-2637, Exhibit B, Sheet 2, April 1950, (Station 550+60)]. FS Date: 6/1/2017 1:15:55 PM

Flap gate at WS toe.

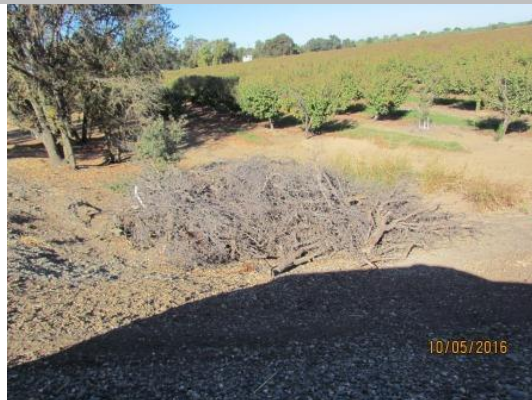
Photo 1 of 1 : FA\_2018\_MA0005\_197\_54\_20180905\_00027.jpg

LM Start	8.34	Rating **	M	Issue No.	54
LM End	8.34	Issue Type +	En	Location *	LS
Category	Earthen Levee			GPS Latitude/Longitude	
				Start	End
Item	Encroachments			39.612230 °	39.612230 °
				-121.782897 °	-121.782897 °
DWR ID	DWR_MA0005_02_f _ 2016_54				
Comment Code					
PR : Prunings					
Inspector Comment					
Remove the prunings from the landside slope.

View of the prunings along the landside toe.

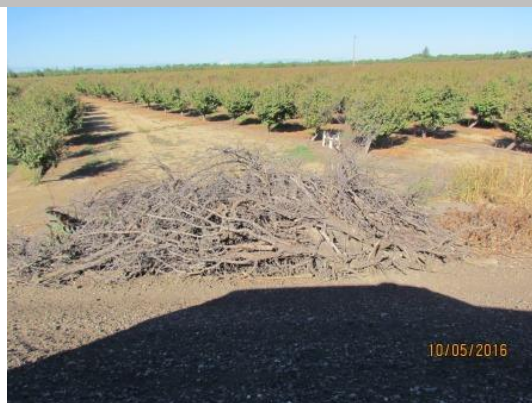
Photo 1 of 1 : FA\_2018\_MA0005\_197\_47\_20180905\_00022.jpg

LM Start	8.67	Rating **	M	Issue No.	47
LM End	8.67	Issue Type +	En	Location *	LS
Category	Earthen Levee			GPS Latitude/Longitude	
				Start	End
Item	Encroachments			39.616370 °	39.616370 °
				-121.779779 °	-121.779779 °
DWR ID	DWR_MA0005_02_s_2016_47				
Comment Code					
PR : Prunings					
Inspector Comment					
Remove the prunings from the landside slope.

View of the prunings along the landside toe.

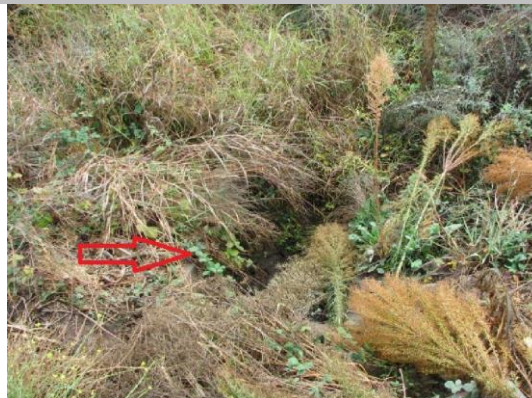
Photo 3 of 3 : UCIP\_FA\_2018\_52061\_68395.jpg

FS\_ID:52061  
DS\_ID:1663  
EP\_NO: N/A  
Repair Type: No Action Needed  
Crossing Status: Found  
UCIP Comments: 5/18/2017 Crossing appears to be in good condition. Pipe has been selected to be internally cleaned and inspected as part of the DMP project. (DWR Sutter Yard- AFreitag)11/14/2016 Crossing appears to be in good condition. (DWR Sutter Yard- AFreitag)5/12/2016 Crossing appears to be in good condition. 7/30/2015 Crossing appears in good condition. No noticeable issues to report. 11/24/2014 Same as last inspection. 6/4/2014 Same as last inspection. 11/13/2013 Damaged pipe section was dug up and replaced. New WS flapgate with u-shaped wingwall installed on end of pipe. 6/6/2013 Same as last inspection. Plans have been made to repair during summer of 2013 before high water season. 11/01/2012 Pipe rusted through along bottom at WS outlet. Sink hole over pipe on WS berm. WS headwall eroded eternally around backside of headwall.

Concrete U shaped outlet and flap gate at WS of Berm.

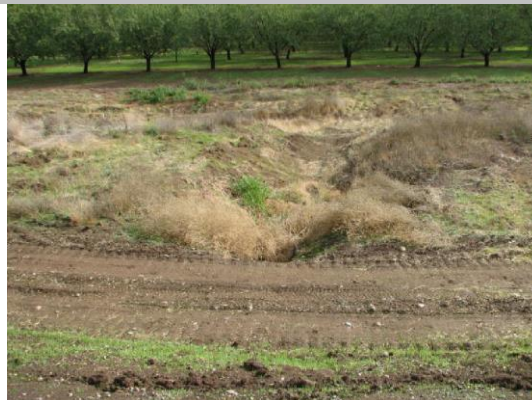
Photo 1 of 3 : UCIP\_FA\_2018\_52064\_68417.jpg

Comment Code					
Inspector Comment					
FS_ID:52064 DS_ID:1666 EP_NO: N/A Repair Type: Non-Urgent Crossing Status: Found UCIP Comments: 5/18/2017 LS inlet half full of soil and WS flap gate half buried by sediment. Pipe has been selected to be internally cleaned and inspected as part of the DMP project. (DWR Sutter Yard-AFreitag)11/14/2016 LS pipe inlet is half full of soil. WS flap gate shut but half buried by sediment. (DWR Sutter Yard-AFreitag)5/12/2016 Pipe is half full of soil.7/30/2015 Pipe is 1/4 to 1/2 full of soil still.11/24/2014 Same as last inspection.6/4/2014 Same as last inspection.11/13/2013 Same as last inspection.6/6/2013 Same as last inspection.11/01/2012 Pipe 1/2 filled with soil. FIELD_STRUCT_DESC: 24-inch corrugated metal drainage pipe through the levee, 11.2 feet below the crown. Flap gate on the waterside (WS). Concrete ""U"" shaped headwalls on both the landside (LS) and the WS. [Additional Reference(s): DWR Levee Log, 1990. USACE Sacramento O&M Manual 516, April 1960, (Station 304+10). USACE As-Built Drawing No. 50-4-3367, Exhibit B, Sheet 3, April 1957, (Station 304+10)]. FS Date: 6/1/2017 1:34:12 PM

View of outlet looking toward WS toe.

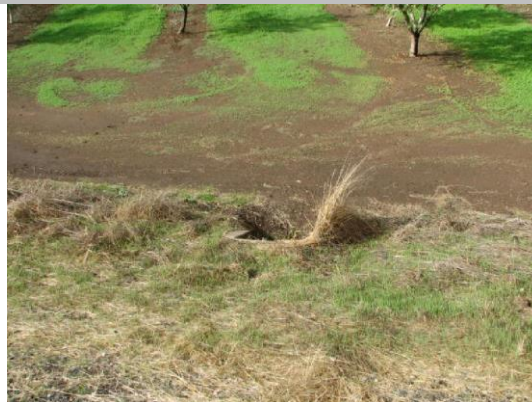
Photo 2 of 3 : UCIP\_FA\_2018\_52064\_68416.jpg

View of inlet on LS toe.

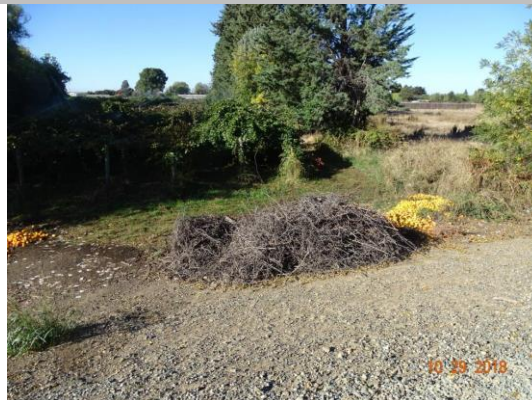
Photo 1 of 1 : FA\_2018\_MA0005\_197\_67\_20181102\_00102.jpg

LM Start	10.22	Rating **	M	Issue No.	67
LM End	10.22	Issue Type +	En	Location *	LS
Category	Earthen Levee			GPS Latitude/Longitude	
				Start	End
Item	Encroachments			39.637030 °	39.637030 °
				-121.779870 °	-121.779870 °
DWR ID	DWR_MA0005_02_f _ 2018_67				
Comment Code					
PR : Prunings					
Inspector Comment					
Remove the prunings from the landside toe.

View of the prunings along the landside toe.

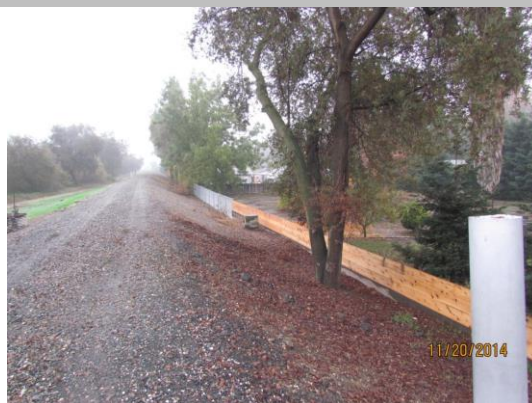
Photo 1 of 1 : FA\_2018\_MA0005\_197\_41\_20180905\_00017.jpg

LM Start	10.90	Rating **	U	Issue No.	41
LM End	10.93	Issue Type +	En	Location *	LS
Category	Earthen Levee			GPS Latitude/Longitude	
				Start	End
Item	Encroachments			39.645508 °	39.645858 °
				-121.786515 °	-121.786742 °
DWR ID	DWR_MA0005_02_f_2014_41				
Comment Code					
FE : Fence					
Inspector Comment					
Remove or apply for permit for the fence along landside toe

View of the new fence along the landside toe.

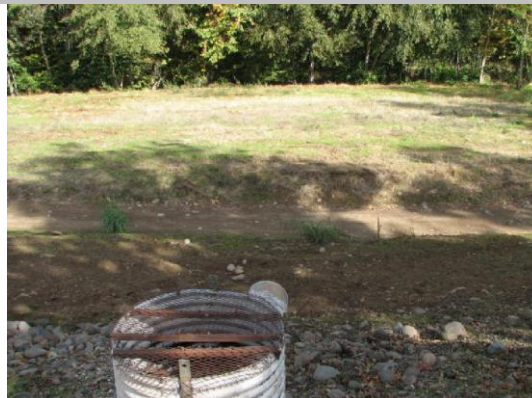
Photo 1 of 3 : UCIP\_FA\_2018\_52069\_68429.jpg

Comment Code						
Inspector Comment						
FS_ID:52069 DS_ID:1670 EP_NO: N/A Repair Type: Non-Urgent Crossing Status: Found UCIP Comments: 5/18/2017 Appears abandoned- Slide gates in WS riser and LS distribution box missing. Pipe has been selected to be internally cleaned and inspected as part of the DMP project. (DWR Sutter Yard- AFreitag)11/14/2016 Appears abandoned- Slide gates in WS riser and LS distribution box missing. (DWR Sutter Yard- AFreitag)5/11/2016 Crossing appears to be in good condition.7/30/2015 Crossing appears in good condition. No noticeable issues to report.11/24/2014 Same as last inspection.6/4/2014 Same as last inspection.11/13/2013 Same as last inspection.6/6/2013 New flap gate installed on WS end of pipe. FIELD_STRUCT_DESC: 24-inch corrugated metal (not 18-inch concrete as shown in the as-built drawing) irrigation pipe through the levee, 9.7 feet below the crown. Slide gate in corrugated metal riser on the waterside (WS) slope. Flap gate on the WS toe. Slide gate in concrete distribution box on the landside (LS). [Additional Reference(s): DWR Levee Log, 1990. USACE Sacramento O&M Manual 516, April 1960, (Station 215+65). USACE As-Built Drawing No. 50-4-3367, Exhibit B, Sheet 2, April 1957, (Station 215+65)]. FS Date: 6/1/2017 1:43:12 PM

CM riser on WS shoulder-missing slide gate.

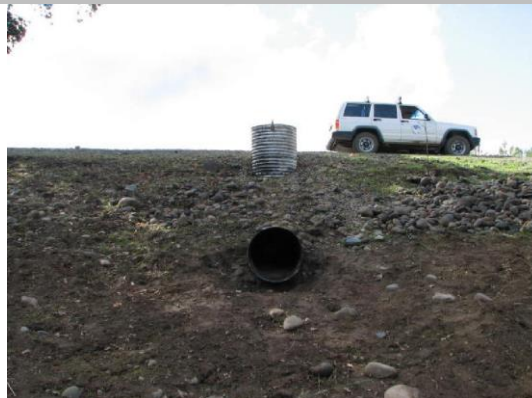
Photo 3 of 3 : UCIP\_FA\_2018\_52069\_68432.jpg

View of pipe from WS looking toward LS.

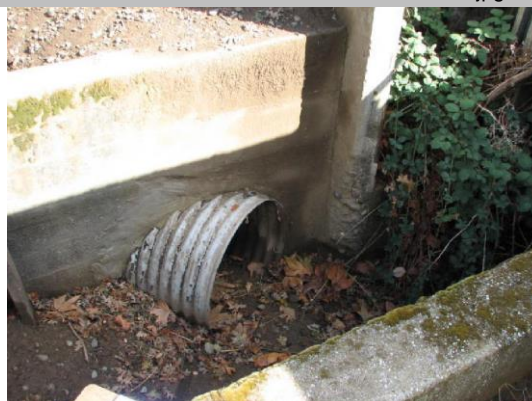
Photo 1 of 3 : UCIP\_FA\_2018\_52070\_68436.jpg

Comment Code						
Inspector Comment						
FS_ID:52070						
DS_ID:1671						
EP_NO: N/A						
Repair Type: Non-Urgent						
Crossing Status: Found						
UCIP Comments: 5/18/2017 Abandoned- WS end still buried. (DWR Sutter Yard- AFreitag)11/14/2016 Appears abandoned. (DWR Sutter Yard- AFreitag)5/11/2016 Abandoned crossing7/30/2015 Abandoned crossing. Unable to locate the WS end of pipe.11/24/2014 Same as last inspection.6/4/2014 Same as last inspection.11/13/2013 Same as last inspection.6/6/2013 Same as last inspection.11/01/2012 Pipe appears abandoned. It needs to be abandoned properly.						
FIELD_STRUCT_DESC: 30-inch corrugated metal irrigation pipe through the levee, 9.4 feet below the crown. Slide gate in a 42-inch corrugated metal riser on the waterside (WS) slope. Concrete distribution box on the landside (LS). [Additional Reference(s): DWR Levee Log, 1990. USACE Sacramento O&M Manual 516, April 1960, (Station 215+46)].

Pipe at concrete distribution box on LS toe.

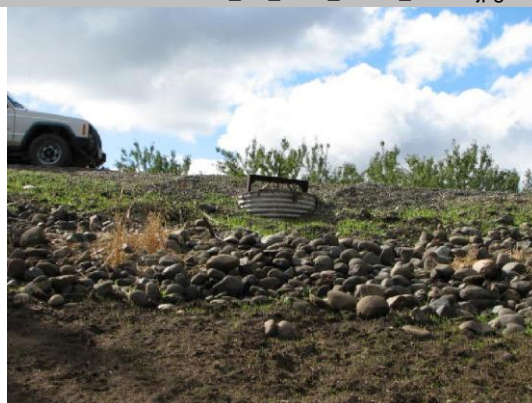
Photo 2 of 3 : UCIP\_FA\_2018\_52070\_68435.jpg

CM riser with slide gate on WS shoulder.

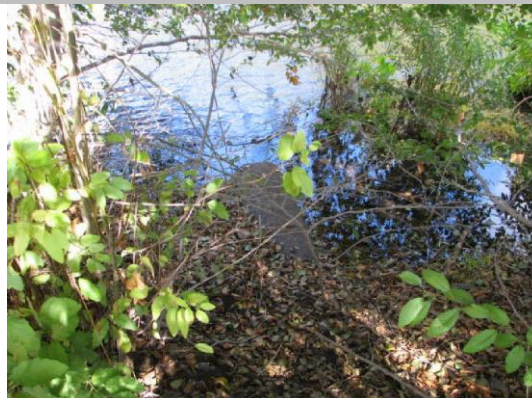
Photo 3 of 3 : UCIP\_FA\_2018\_52070\_68434.jpg

Comment Code						
Inspector Comment						
FS_ID:52070						
DS_ID:1671						
EP_NO: N/A						
Repair Type: Non-Urgent						
Crossing Status: Found						
UCIP Comments: 5/18/2017 Abandoned- WS end still buried. (DWR Sutter Yard- AFreitag)11/14/2016 Appears abandoned. (DWR Sutter Yard- AFreitag)5/11/2016 Abandoned crossing7/30/2015 Abandoned crossing. Unable to locate the WS end of pipe.11/24/2014 Same as last inspection.6/4/2014 Same as last inspection.11/13/2013 Same as last inspection.6/6/2013 Same as last inspection.11/01/2012 Pipe appears abandoned. It needs to be abandoned properly.						
FIELD_STRUCT_DESC: 30-inch corrugated metal irrigation pipe through the levee, 9.4 feet below the crown. Slide gate in a 42-inch corrugated metal riser on the waterside (WS) slope. Concrete distribution box on the landside (LS). [Additional Reference(s): DWR Levee Log, 1990. USACE Sacramento O&M Manual 516, April 1960, (Station 215+46)].

Concrete pipe at edge of creek on WS.

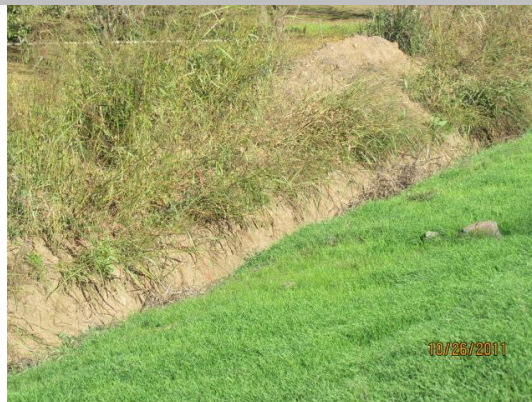
Photo 1 of 1 : FA\_2018\_MA0005\_197\_6\_20180905\_00003.jpg

LM Start	11.57	Rating **	M	Issue No.	6
LM End	11.77	Issue Type +	En	Location *	LS
Category	Earthen Levee			GPS Latitude/Longitude	
				Start	End
Item	Encroachments			39.654349 °	39.657142 °
				-121.789531 °	-121.788690 °
DWR ID	DWR_MA0005_02_s_2012_6				
Comment Code					
DT : Ditch					
Inspector Comment

View of the ditch along the Landside toe.

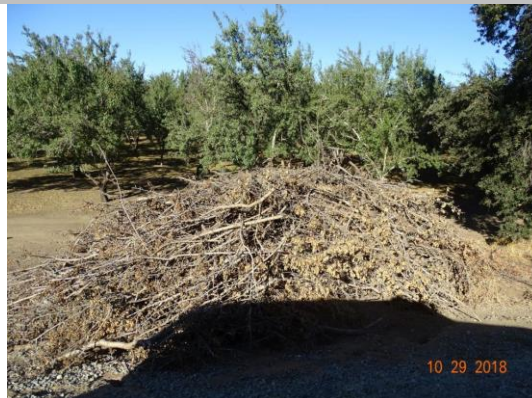
Photo 1 of 1 : FA\_2018\_MA0005\_197\_70\_20181102\_00105.jpg

View of the prunings along the landside toe.

LM Start	11.77	Rating **	M	Issue No.	70
LM End	11.77	Issue Type +	En	Location *	LS
Category	Earthen Levee			GPS Latitude/Longitude	
				Start	End
Item	Encroachments			39.657115 °	39.657115 °
				-121.788703 °	-121.788703 °
DWR ID	DWR_MA0005_02_f_2018_70				
Comment Code					
PR : Prunings					
Inspector Comment					
Remove the prunings from the landside toe.

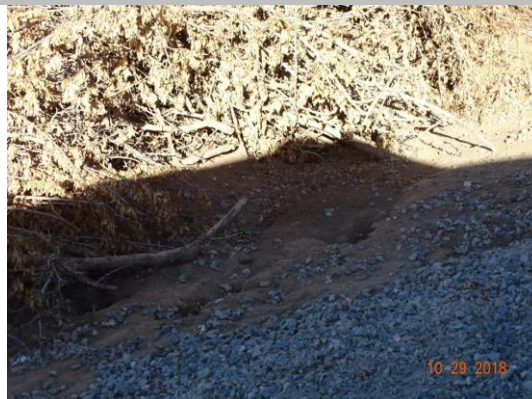
Photo 1 of 1 : FA\_2018\_MA0005\_197\_71\_20181102\_00106.jpg

View of the rodent holes along the landside slope.

LM Start	11.77	Rating **	M	Issue No.	71
LM End	11.77	Issue Type +	Ma	Location *	LS
Category	Earthen Levee			GPS Latitude/Longitude	
				Start	End
Item	Animal Control			39.657115 °	39.657115 °
				-121.788703 °	-121.788703 °
DWR ID	DWR_MA0005_02_f_2018_71				
Comment Code					
A3 : No rodents visible, but rodent burrows visible; need to backfill and compact or grout burrows.					
Inspector Comment					
Repair the rodent holes along the landside slope.

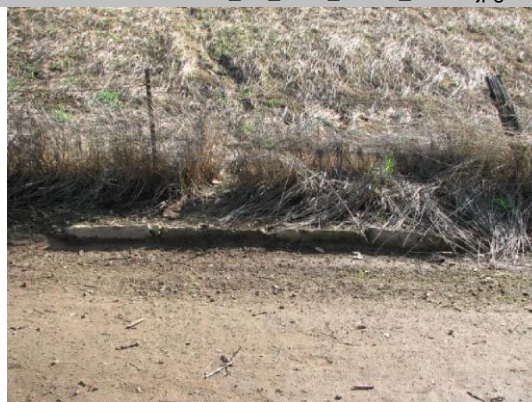
Photo 2 of 3 : UCIP\_FA\_2018\_52072\_68464.jpg

Comment Code						
Inspector Comment						
FS_ID:52072						
DS_ID:1673						
EP_NO: N/A						
Repair Type: Non-Urgent						
Crossing Status: Found						
UCIP Comments: 5/18/2017 Abandoned- needs to be done properly.						
Pipe has been selected to be internally cleaned and inspected as part						
of the DMP project. (DWR Sutter Yard- A Freitag)11/14/2016						
Abandoned- needs a cover for standpipe. (DWR Sutter Yard-						
A Freitag)5/11/2016 Abandoned crossing. Needs a cover fo the WS						
riser.8/3/2015 Crossing appears abandoned. Only the slide gate						
inside riser on the WS shoulder could be found. Riser needs a cover						
made for it.11/24/2014 Same as last inspection.6/4/2014 Same as						
last inspection.11/13/2013 Slide gate top and stem were repaired to						
make gate operational.6/6/2013 New slidegate is planned to be						
installed during summer of 2013.11/01/2012 Slide gate on WS

shoulder bent and damaged (inoperable) Pipe appears abandoned.						
FIELD_STRUCT_DESC: *ABANDONED* 24-inch corrugated metal						
drainage pipe through the levee, 14 feet below the crown. Slide gate in						
a corrugated metal riser on the waterside (WS) slope. [Additional						
Reference(s): DWR Levee Log, 1990. USACE Sacramento O&M						
Manual 516, April 1960, (Station 126+91)].						
FS Date: 6/1/2017 1:52:47 PM

Abandoned headwall on LS toe.

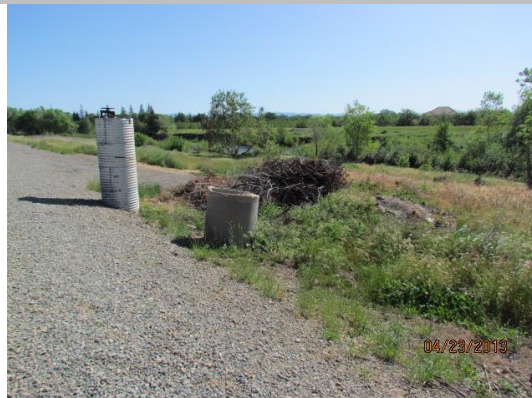
Photo 1 of 1 : FA\_2018\_MA0005\_197\_22\_20180905\_00009.jpg

LM Start	13.15	Rating **	M	Issue No.	22
LM End	13.15	Issue Type +	En	Location *	WS
Category	Earthen Levee			GPS Latitude/Longitude	
				Start	End
Item	Encroachments			39.675311 °	39.675311 °
				-121.780371 °	-121.780371 °
DWR ID	DWR_MA0005_02_s_2013_22				
Comment Code					
PR : Prunings					
Inspector Comment

View of the prunings along the waterside toe.

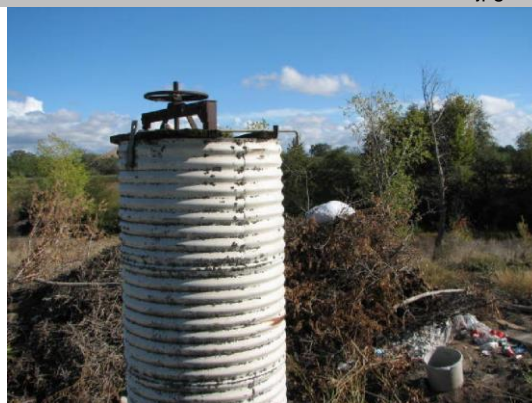
Photo 1 of 1 : UCIP\_FA\_2018\_52073\_68488.jpg

Comment Code						
Inspector Comment						
FS_ID:52073 DS_ID:1674 EP_NO: 1291 Repair Type: Non-Urgent Crossing Status: Found UCIP Comments: 5/18/2017 Appears abandoned- needs to be done properly. (DWR Sutter Yard- AFreitag)11/14/2016 Appears abandoned- needs to be done so properly (DWR Sutter Yard- AFreitag)5/11/2016 Appears to be an abandoned crossing.8/3/2015 Pipe appears to be abandoned. Pump on WS berm is still missing.11/24/2014 Same as last inspection.6/4/2014 Same as last inspection.11/13/2013 Same as last inspection.6/6/2013 Same as last inspection.11/01/2012 Pipe appears to be abandoned. No pump found. Pipe should be abandoned properly. FIELD_STRUCT_DESC: 24-inch corrugated metal (not 14-inch concrete as described in the permit) irrigation pipe through the levee, 9 feet below the crown. Slide gate in a 36-inch corrugated metal riser on the waterside (WS) slope. Pump and a 36-inch concrete standpipe on the WS. (Originally installed under Permit No. 1291, 1948 - J. P. Hansen). [Additional Reference(s): DWR Levee Log, 1990. USACE Sacramento O&M Manual 516, April 1960, (Station 106+93)]. FS Date: 6/1/2017 1:54:43 PM

Slide gate in CM riser on WS toe.

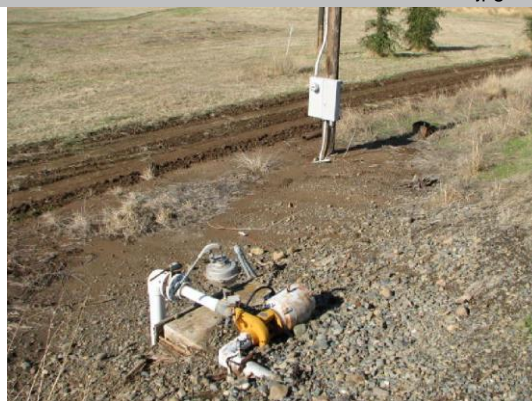
Photo 1 of 1 : UCIP\_FA\_2018\_52074\_68489.jpg

Item	DWR UCIP Field Study		39.677309°	39.677309°	
			-121.778668°	-121.778668°	
DWR ID	1675				
Comment Code					
Inspector Comment					
FS_ID:52074 DS_ID:1675 EP_NO: N/A Repair Type: Non-Urgent Crossing Status: Found UCIP Comments: 5/18/2017 LS visible but nothing found on WS of levee. (DWR Sutter Yard- AFreitag)11/14/2016 Still unable to locate and WS appurtenances. (DWR Sutter Yard- AFreitag)5/11/2106 LS seems fine but nothing was found on the WS8/3/2015 Still unable to locate anything on the WS.11/24/2014 Same as last inspection.6/4/2014 Same as last inspection.11/13/2013 Same as last inspection.6/6/2013 Same as last inspection.11/01/2012 Unable to locate pipe on WS. FIELD_STRUCT_DESC: 8-inch steel irrigation pipe, 4 feet below the crown. Pipe is sleeved with a 5-inch aluminum irrigation pipe. Pump on a concrete pad on the landside (LS) slope. Butterfly valve on the LS slope. [Additional Reference(s): DWR Levee Log, 1990]. FS Date: 6/1/2017 1:56:04 PM

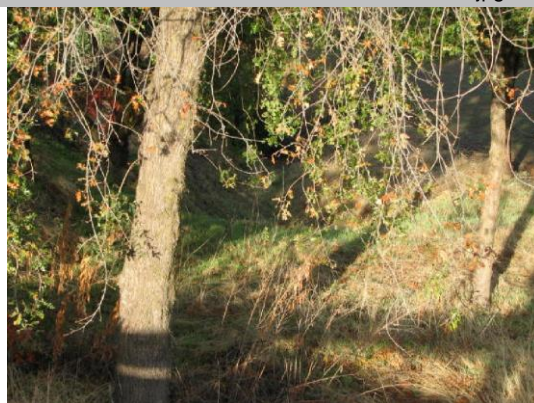
Photo 1 of 3 : UCIP\_FA\_2018\_52083\_68531.jpg

Comment Code						
Inspector Comment						
FS_ID:52083 DS_ID:1679 EP_NO: N/A Repair Type: No Action Needed Crossing Status: Found UCIP Comments: 5/18/2017 Crossing appears to be in good condition. Pipe has been selected to be internally cleaned and inspected as part of the DMP project. (DWR Sutter Yard- AFreitag)11/14/2016 Crossing appears to be in good condition. (DWR Sutter Yard- AFreitag)5/11/2016 Crossing appears to be in good condition. 8/3/2015 Crossing appears in good condition. No noticeable issues to report.11/25/2014 Same as last inspection.6/4/2014 Same as last inspection.11/13/2013 Same as last inspection.6/6/2013 Same as last inspection. FIELD_STRUCT_DESC: 24-inch corrugated metal drainage pipe through the levee, 14.5 feet below the crown. Concrete ""U"" shaped headwall on the waterside (WS). Flap gate on the WS. [Additional Reference(s): DWR Levee Log, 1990. USACE Sacramento O&M Manual 516, April 1960, (Station 93+78)]. FS Date: 6/1/2017 2:09:55 PM

Inlet relocated after bridge replacement away from LS toe.

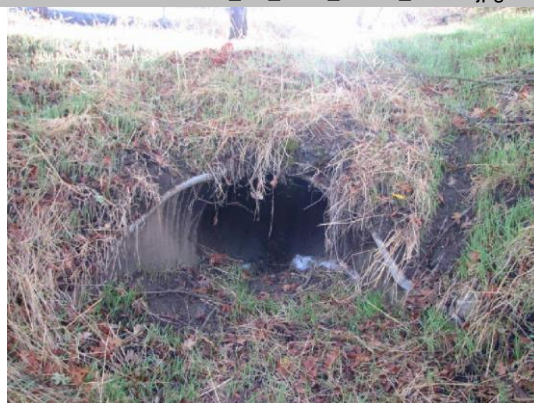
Photo 2 of 3 : UCIP\_FA\_2018\_52083\_68530.jpg

Inlet 50-feet NW of levee crown.

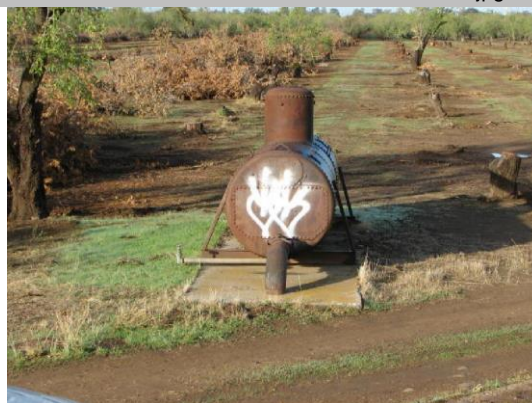
Photo 1 of 1 : UCIP\_FA\_2018\_52084\_68534.jpg

Comment Code					
Inspector Comment					
FS_ID:52084 DS_ID:1680 EP_NO: N/A Repair Type: Non-Urgent Crossing Status: Found UCIP Comments: 5/18/2017 Unable to locate. (DWR Sutter Yard-AFreitag)11/14/2016 Unable to locate. (DWR Sutter Yard-AFreitag)5/11/2016 Unable to locate.8/3/2015 Unable to locate.11/25/2014 Unable to locate.6/4/2014 Same as last inspection. Unable to locate.11/13/2013 Unable to locate.6/6/2013 Boiler has been removed and pipe buried on LS. Unable to locate.11/01/2012 Pipe appears to be abandoned. FIELD_STRUCT_DESC: 8-inch steel irrigation pipe through the levee, 6.5 feet below the crown. Boiler attached to the landside (LS). [Additional Reference(s): DWR Levee Log, 1990. USACE Sacramento O&M Manual 516, April 1960, (Station 73+27)]. FS Date: 6/1/2017 2:11:21 PM

Pipe attached at boiler on LS toe.

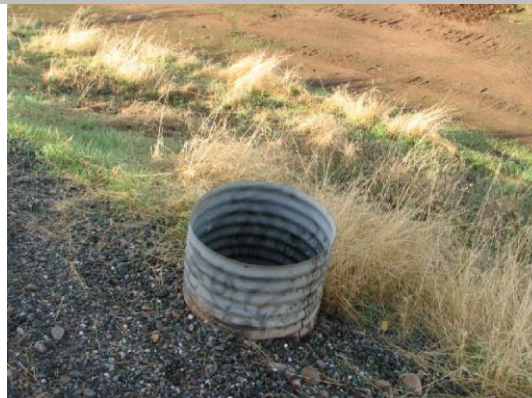
Photo 1 of 1 : UCIP\_FA\_2018\_52085\_68535.jpg

Comment Code						
Inspector Comment						
FS_ID:52085 DS_ID:1681 EP_NO: N/A Repair Type: Non-Urgent Crossing Status: Found UCIP Comments: 5/18/2017 Appears abandoned- if so needs to be done so properly. (DWR Sutter Yard- A Freitag)11/14/2016 Appears abandoned (DWR Sutter Yard- A Freitag)5/11/216 Abandoned crossing8/3/2015 Pipe still appears abandoned.11/25/2014 Same as last inspection.6/4/2014 Same as last inspection.11/13/2013 Same as last inspection.6/6/2013 Same as last inspection.11/01/2012 Pipe appears to be abandoned. FIELD_STRUCT_DESC: *ABANDONED* 6-inch steel irrigation pipe through the levee, 7.1 feet below the crown. Siphon breaker in a corrugated metal riser on the landside (LS) slope. One corrugated metal cutoff wall. Pipe is open on both ends. [Additional Reference(s): DWR Levee Log, 1990. USACE Sacramento O&M Manual 516, April 1960, (Station 65+52)]. FS Date: 6/1/2017 2:12:13 PM

CM riser with siphon breaker on LS shoulder.

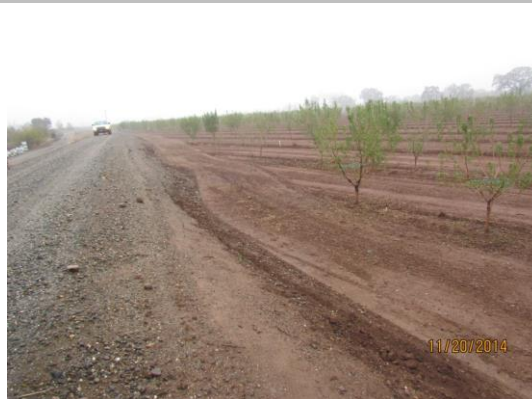
Photo 1 of 1 : FA\_2018\_MA0005\_197\_43\_20180905\_00019.jpg

LM Start	14.13	Rating **	M	Issue No.	43
LM End	14.13	Issue Type +	Ma	Location *	LS
Category	Earthen Levee			GPS Latitude/Longitude	
				Start	End
Item	Slope Stability			39.688715 °	39.688715 °
				-121.778345 °	-121.778345 °
DWR ID	DWR_MA0005_02_f_2014_43				
Comment Code					
S1 : Repair slope instability.					
Inspector Comment					
The landowner disked into the slope of the levee.

View of the tilling into the landside slope.

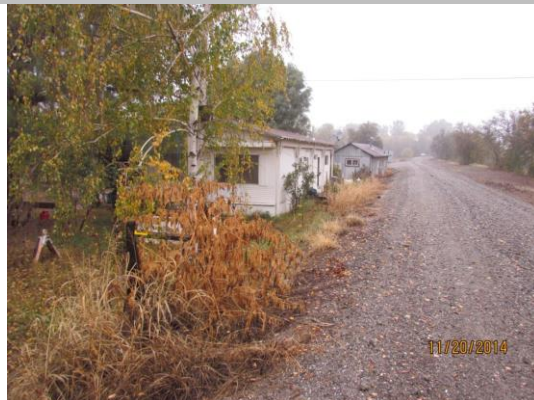
Photo 1 of 1 : FA\_2018\_MA0005\_197\_25\_20180905\_00010.jpg

View of the buildings at the landside toe.

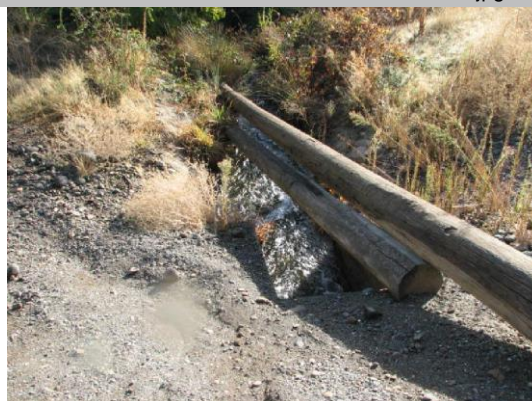
Photo 1 of 3 : UCIP\_FA\_2018\_52086\_68544.jpg

Comment Code					
Inspector Comment					
FS_ID:52086					
DS_ID:1682					
EP_NO: N/A					
Repair Type: No Action Needed					
Crossing Status: Found					
UCIP Comments: 5/18/2017 Crossing appears to be in good condition.					
Pipe has been selected to be internally cleaned and inspected as part					
of the DMP project. (DWR Sutter Yard- AFreitag)11/14/2016					
Crossing appears to be in good condition. (DWR Sutter Yard-					
AFreitag)5/11/2016 Crossing appears to be in good					
condition.8/3/2015 Crossing appears in good condition. No					
noticeable issues to report.11/25/2014 Same as last					
inspection.6/4/2014 Same as last inspection.11/13/2013 Same as					
last inspection.6/6/2013 Same as last inspection.					
FIELD_STRUCT_DESC: 24-inch corrugated metal drainage pipe					
through the levee, 7.2 feet below the crown. Concrete ""U"" shaped					
headwall and grouted spillway on the waterside (WS). Slide gate in a 48-

Outlet at U-shaped headwall on WS toe.

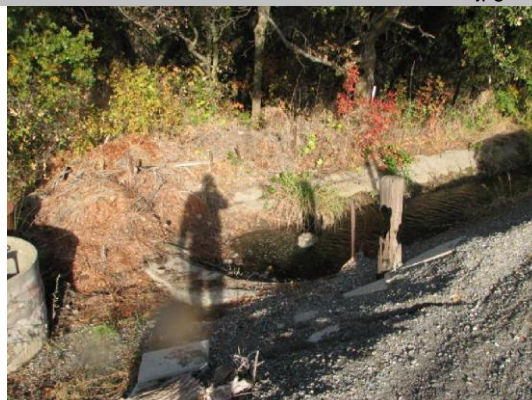
Photo 2 of 3 : UCIP\_FA\_2018\_52086\_68543.jpg

Concrete lined channel on LS toe.

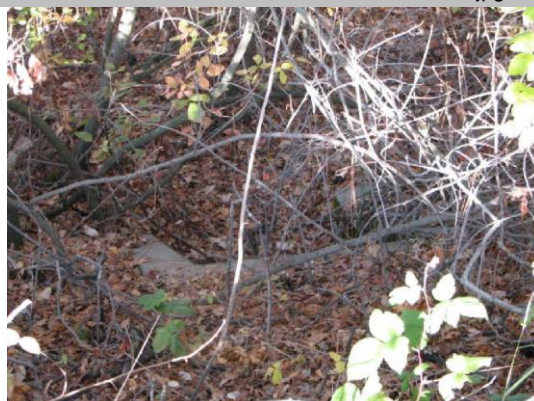
Photo 1 of 2 : UCIP\_FA\_2018\_52087\_68541.jpg

Comment Code						
Inspector Comment						
FS_ID:52087 DS_ID:1683 EP_NO: N/A Repair Type: Non-Urgent Crossing Status: Found UCIP Comments: 5/18/2017 WS appears to be in good condition. LS inlet is across a ditch and inaccessible for inspection due to dense vegetation and being down a very steep slope. Pipe has been selected to be internally cleaned and inspected as part of the DMP project. (DWR Sutter Yard- A Freitag)11/14/2016 Crossing appears to be in good condition. (DWR Sutter Yard- A Freitag)5/11/2016 Crossing appears to be in good condition.8/3/2015 Crossing appears in good condition. No noticeable issues to report.6/6/2013 Same as last inspection.11/13/2013 Same as last inspection.6/4/2014 Same as last inspection.11/25/2014 Same as last inspection. FIELD_STRUCT_DESC: 24-inch corrugated metal drainage pipe through the levee, 14.3 feet below the crown. Concrete ""U"" headwalls on both the landside (LS) and the waterside (WS). Flap gate on the WS. Inlet downhill from a concrete lined channel at the low point on the LS toe. [Additional Reference(s): DWR Levee Log, 1990. USACE Sacramento O&M Manual 516, April 1960, (Station 36+85)]. FS Date: 6/1/2017 2:14:24 PM

Inlet at LS toe.

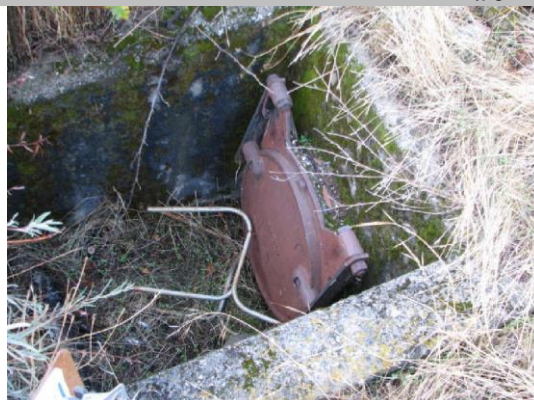
Photo 2 of 2 : UCIP\_FA\_2018\_52087\_68540.jpg

Outlet at WS toe with flap gate and concrete U-shaped headwall.

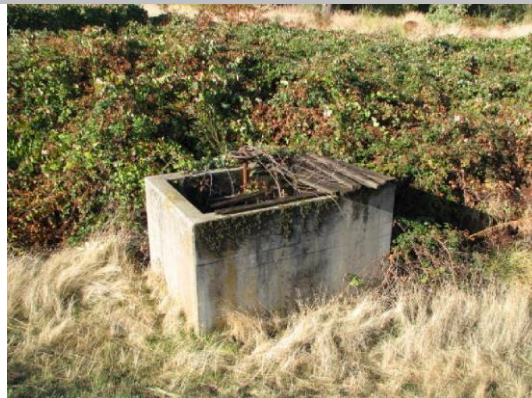
Photo 1 of 2 : UCIP\_FA\_2018\_52090\_68570.jpg

Comment Code					
Inspector Comment					
FS_ID:52090 DS_ID:1685 EP_NO: N/A Repair Type: Non-Urgent Crossing Status: Found UCIP Comments: 5/18/2017 Crossing appears to be in good condition. WS riser needs a cover. (DWR Sutter Yard- AFreitag)11/14/2016 Good condition- needs a cover for the riser. (DWR Sutter Yard- AFreitag)5/11/2016 Needs a cover for riser. The rest of the crossing appears to be in good condition.8/3/2015 Crossing appears in good condition but needs a cover made for the riser.11/25/2014 Same as last inspection.6/4/2014 Same as last inspection.11/13/2013 Same as last inspection.6/6/2013 Same as last inspection. FIELD_STRUCT_DESC: 42-inch steel irrigation pipe (siphon) through the levee, 10 feet below the crown. Slide gate in a 54-inch corrugated metal riser on the waterside (WS) slope. 5-foot by 8-foot concrete distribution box on the landside (LS). Two corrugated metal cutoff walls installed within the levee. [Additional Reference(s): DWR Levee Log, 1990. USACE Sacramento O&M Manual 516, April 1960, (Station 8+30)]. FS Date: 6/1/2017 2:21:26 PM

Concrete distribution box with slide gate on LS toe.

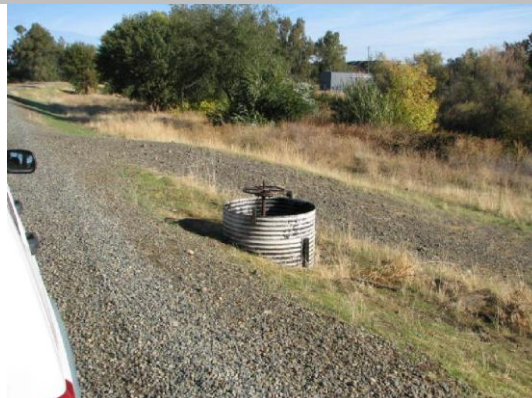
Photo 2 of 2 : UCIP\_FA\_2018\_52090\_68569.jpg

CMP riser on WS shoulder with slide gate.

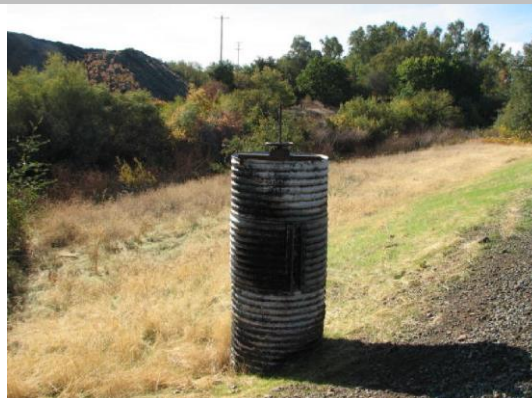
Photo 1 of 2 : UCIP\_FA\_2018\_52091\_68572.jpg

Comment Code						
Inspector Comment						
FS_ID:52091 DS_ID:1686 EP_NO: N/A Repair Type: Non-Urgent Crossing Status: Found UCIP Comments: 5/18/2017 Only WS and LS standpipes visible. (DWR Sutter Yard- AFreitag)11/14/2016 Still only WS standpipe visible. (DWR Sutter Yard- AFreitag)5/11/2016 Only WS standpipe was visible. 8/3/2015 Only able to locate the standpipe on the WS. 11/25/2014 Same as last inspection. 6/4/2014 Same as last inspection. 11/13/2013 Same as last inspection. 6/6/2013 Same as last inspection. FIELD_STRUCT_DESC: 12-inch steel irrigation pipe (siphon) through the levee, 10 feet below the crown. Slide gate in a 36-inch corrugated metal riser on the waterside (WS) slope. 30-inch concrete standpipe at the landside (LS) toe. [Additional Reference(s): DWR Levee Log, 1990. USACE Sacramento O&M Manual 516, April 1960, (Station 145+53)]. FS Date: 6/1/2017 2:22:09 PM

CMP riser on WS slope with slide gate.

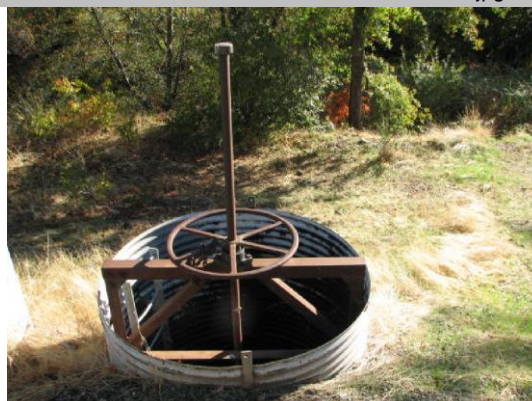
Photo 1 of 3 : UCIP\_FA\_2018\_52092\_68575.jpg

Comment Code						
Inspector Comment						
FS_ID:52092 DS_ID:1687 EP_NO: N/A Repair Type: Non-Urgent Crossing Status: Found UCIP Comments: 5/18/2017 Crossing appears to be in good condition. WS riser needs a cover. (DWR Sutter Yard- AFreitag)11/14/2016 Good condition- needs a cover for standpipe. (DWR Sutter Yard- AFreitag)5/11/2016 Needs a lcover for riser. The rest of the crossing appears in good condition.8/3/2015 Crossing is in good condition but needs a cover made for the riser.11/25/2014 Same as last inspection.6/4/2014 Same as last inspection.11/13/2013 Same as last inspection.6/6/2013 Same as last inspection. Need to construct covers for top of standpipe.11/02/2012 Good candidate for video inspection. FIELD_STRUCT_DESC: 1 of 2: 54-inch corrugated metal irrigation pipe (siphon) through the levee, 17.8 feet below the crown. Slide gate in a 66-inch corrugated metal riser on the waterside (WS). Concrete headwall and irrigation ditch at the landside (LS) toe. Edgar Slough riser units in the floodway. [Additional Reference(s): DWR Levee Log, 1990. USACE Sacramento O&M Manual 516, April 1960, (Station 132+00)]. FS Date: 6/1/2017 2:23:32 PM

66-inch CMP riser on WS shoulder with slide gate.

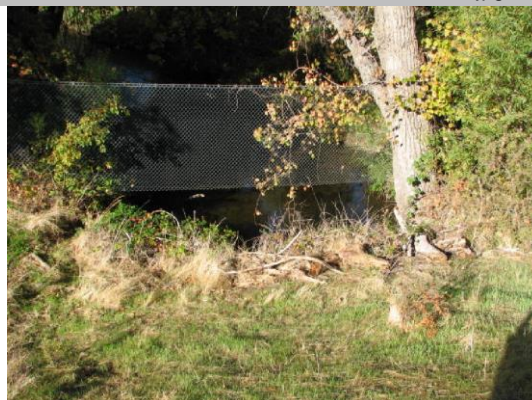
Photo 2 of 3 : UCIP\_FA\_2018\_52092\_68574.jpg

Irrigation ditch at LS toe.

Comment Code						
Inspector Comment						
FS_ID:52092 DS_ID:1687 EP_NO: N/A Repair Type: Non-Urgent Crossing Status: Found UCIP Comments: 5/18/2017 Crossing appears to be in good condition. WS riser needs a cover. (DWR Sutter Yard- AFreitag)11/14/2016 Good condition- needs a cover for standpipe. (DWR Sutter Yard- AFreitag)5/11/2016 Needs a lcover for riser. The rest of the crossing appears in good condition.8/3/2015 Crossing is in good condition but needs a cover made for the riser.11/25/2014 Same as last inspection.6/4/2014 Same as last inspection.11/13/2013 Same as last inspection.6/6/2013 Same as last inspection. Need to construct covers for top of standpipe.11/02/2012 Good candidate for video inspection. FIELD_STRUCT_DESC: 1 of 2: 54-inch corrugated metal irrigation pipe (siphon) through the levee, 17.8 feet below the crown. Slide gate in a 66-inch corrugated metal riser on the waterside (WS). Concrete headwall and irrigation ditch at the landside (LS) toe. Edgar Slough riser units in the floodway. [Additional Reference(s): DWR Levee Log, 1990. USACE Sacramento O&M Manual 516, April 1960, (Station 132+00)]. FS Date: 6/1/2017 2:23:32 PM

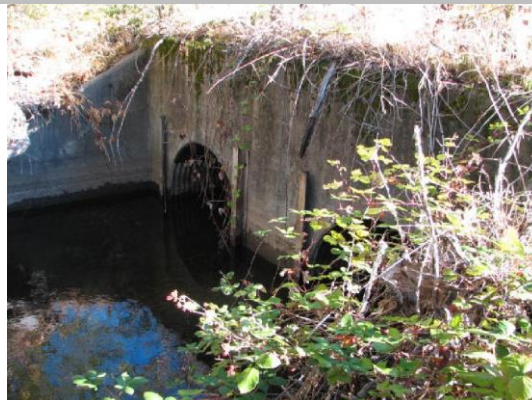
Photo 3 of 3 : UCIP\_FA\_2018\_52092\_68573.jpg

Concrete headwall on LS toe.

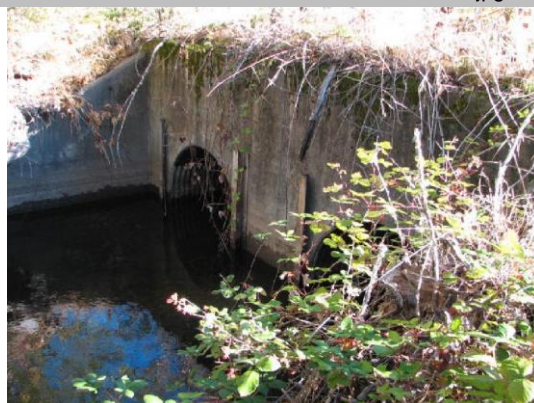
Photo 1 of 3 : UCIP\_FA\_2018\_52093\_68579.jpg

Comment Code					
Inspector Comment					
FS_ID:52093 DS_ID:16316 EP_NO: N/A Repair Type: Non-Urgent Crossing Status: Found UCIP Comments: 5/18/2017 Crossing appears to be in good condition. WS riser needs a cover. (DWR Sutter Yard- A Freitag)11/14/2016 Good condition- needs a cover for standpipe. (DWR Sutter Yard- A Freitag)5/11/2016 Needs a lcover for riser. The rest of the crossing appears in good condition.8/3/2015 Crossing appears in good condition but needs a cover made for the riser.11/25/2014 Same as last inspection.6/4/2014 Same as last inspection.11/13/2013 Same as last inspection.6/6/2013 Same as last inspection. Need to construct cover for top of standpipe.11/01/2012 Good candidate for video inspection. FIELD_STRUCT_DESC: 2 of 2: 54-inch corrugated metal irrigation pipe (siphon) through the levee, 17.8 feet below the crown. Slide gate in a 66-inch corrugated metal riser on the waterside (WS). Concrete headwall and irrigation ditch at the landside (LS) toe. Edgar Slough riser units in the floodway. [Additional Reference(s): DWR Levee Log, 1990. USACE Sacramento O&M Manual 516, April 1960, (Station 132+00)]. FS Date: 6/1/2017 2:24:17 PM

Concrete headwall at LS toe.

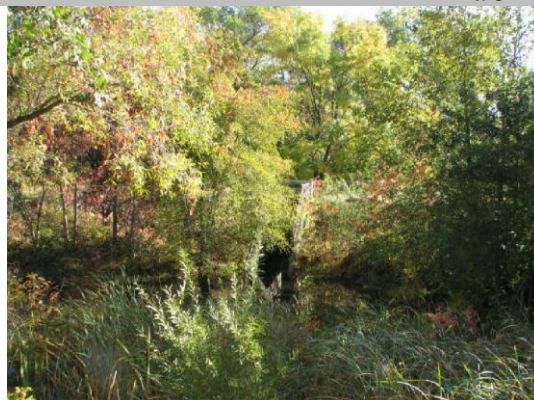
Photo 2 of 3 : UCIP\_FA\_2018\_52093\_68578.jpg

Related structure out in floodway.

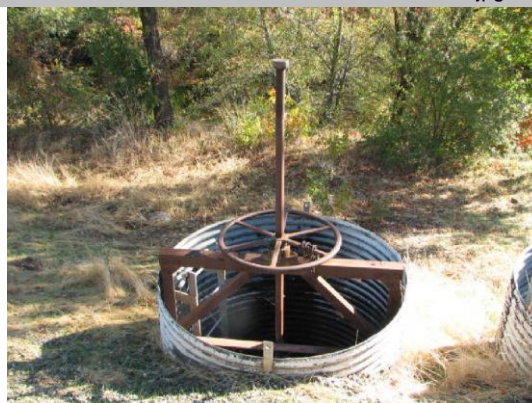
Photo 3 of 3 : UCIP\_FA\_2018\_52093\_68577.jpg

Comment Code						
Inspector Comment						
FS_ID:52093 DS_ID:16316 EP_NO: N/A Repair Type: Non-Urgent Crossing Status: Found UCIP Comments: 5/18/2017 Crossing appears to be in good condition. WS riser needs a cover. (DWR Sutter Yard- AFreitag)11/14/2016 Good condition- needs a cover for standpipe. (DWR Sutter Yard- AFreitag)5/11/2016 Needs a lcover for riser. The rest of the crossing appears in good condition.8/3/2015 Crossing appears in good condition but needs a cover made for the riser.11/25/2014 Same as last inspection.6/4/2014 Same as last inspection.11/13/2013 Same as last inspection.6/6/2013 Same as last inspection. Need to construct cover for top of standpipe.11/01/2012 Good candidate for video inspection. FIELD_STRUCT_DESC: 2 of 2: 54-inch corrugated metal irrigation pipe (siphon) through the levee, 17.8 feet below the crown. Slide gate in a 66-inch corrugated metal riser on the waterside (WS). Concrete headwall and irrigation ditch at the landside (LS) toe. Edgar Slough riser units in the floodway. [Additional Reference(s): DWR Levee Log, 1990. USACE Sacramento O&M Manual 516, April 1960, (Station 132+00)]. FS Date: 6/1/2017 2:24:17 PM

66-inch CMP riser on WS shoulder.
